FINAL DRAFT
CULTURAL LANDSCAPE REPORT/
ENVIRONMENTAL ASSESSMENT

Jewel Cave Historic Area

Jewel Cave National Monument

MARCH 2005

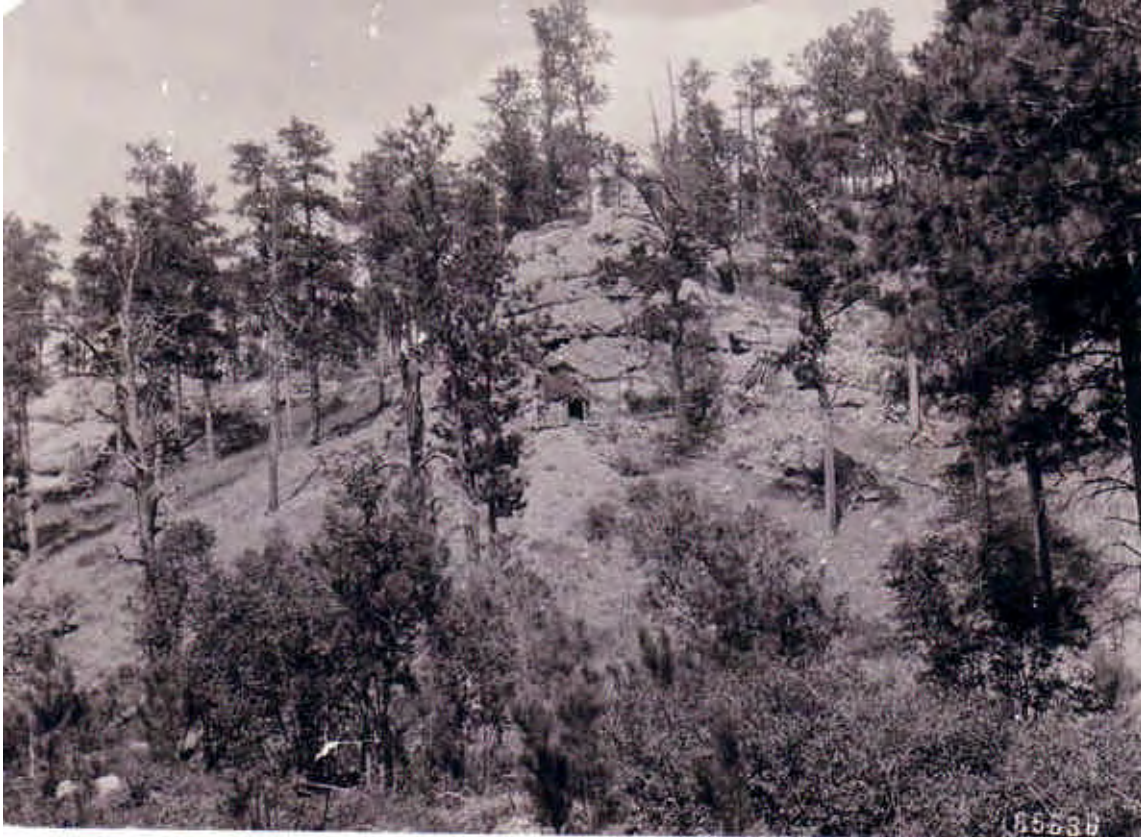
Figure 2.8: 1916 Historic Cave Entrance Overview (Source: JECA 2645)

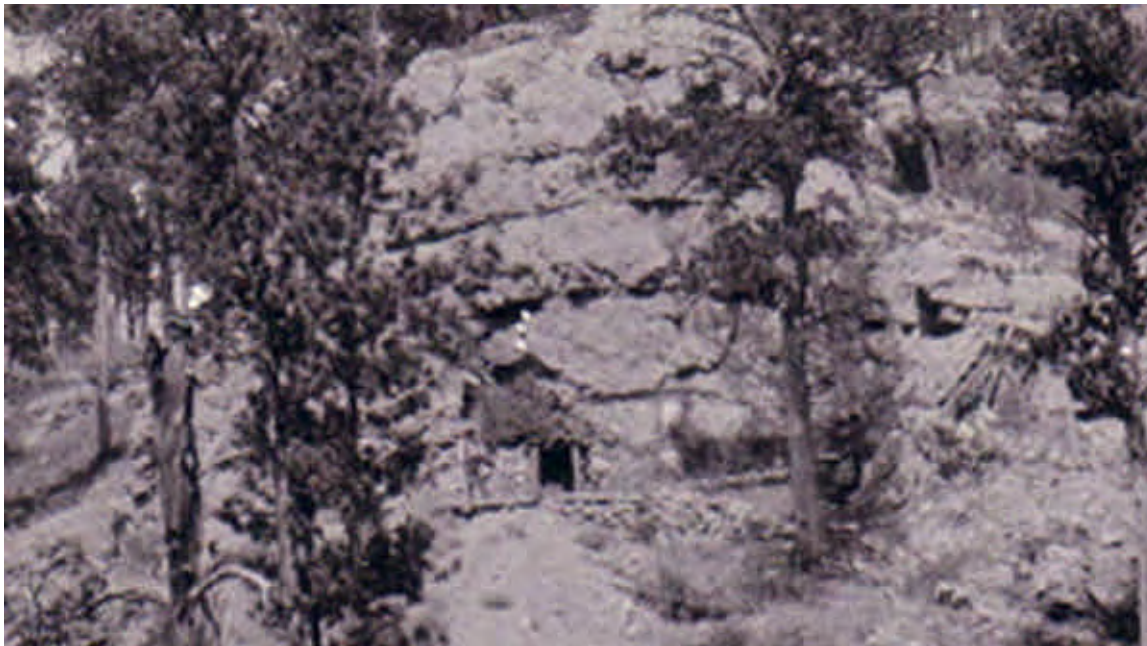
Figure 2.10: 1916 Historic Cave Entrance Close-Up (Source: JECA 2645)

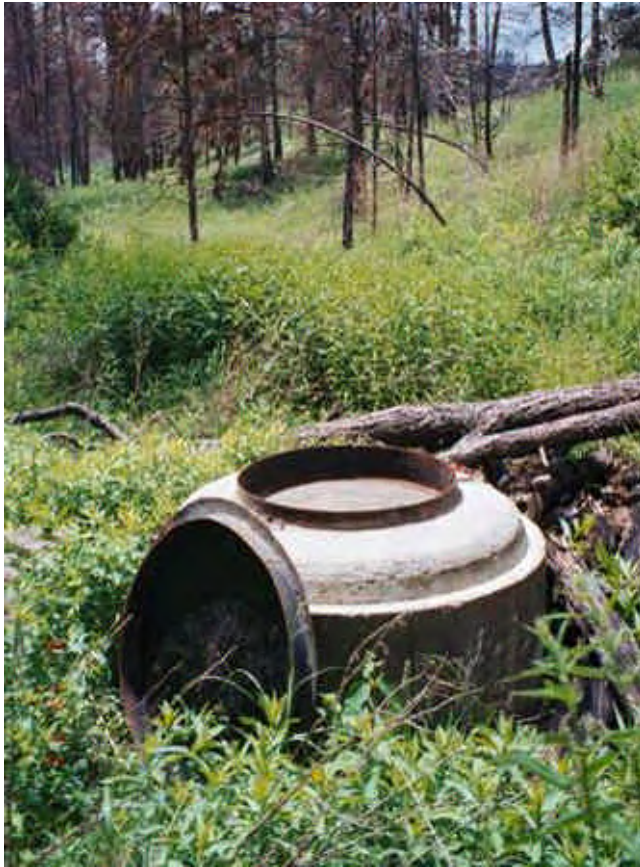
Figure 3.7: Manhole Structure at Seep/Spring near former Michaud Hotel Site (source: QE|A 2003, Roll1 AA007A)

The Michaud archeological site includes some remnants of stone foundation walls and a later concrete manhole-type structure at the spring.

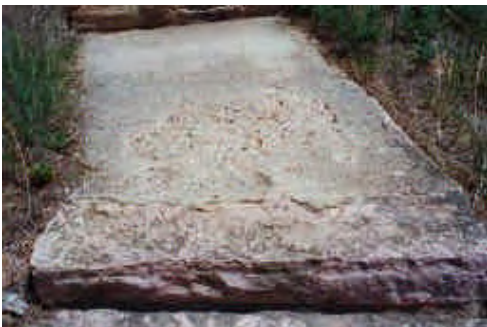
Figure 3.29: Upper trail stone step 10, deteriorating concrete (Source: QE|A 2003, Roll4-12)

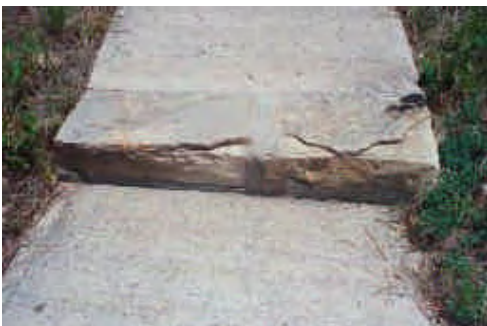
Figure 3.31: Upper trail stone step 12, cracking edge (Source: QE|A 2003, Roll4-14)

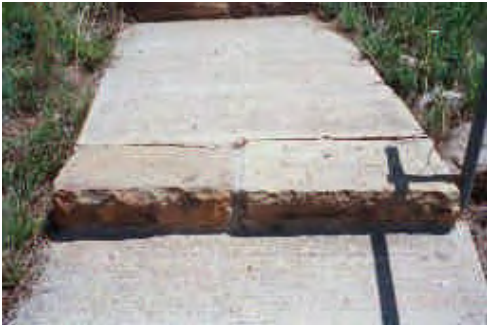
Figure 3.32: Upper trail stone step 13, pulling away from concrete (Source: QE|A 2003, Roll4-16)

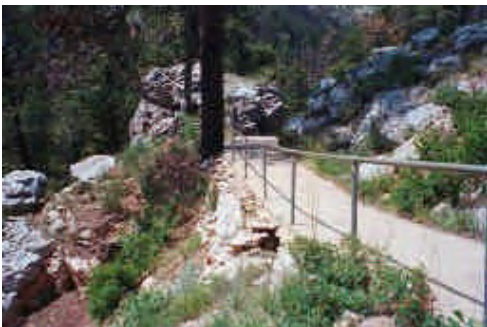
Figure 3.33: Upper trail curve near stairway, failing concrete (Source: QE|A 2003, Roll4-18)

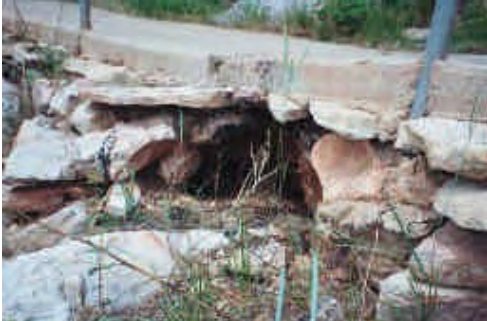
Figure 3.34: Detail of structural failure at curve in upper trail (Source: QE|A, Roll4-20)

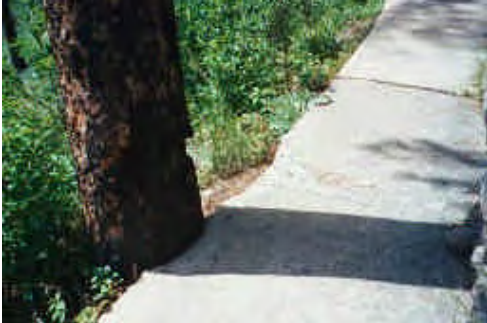
Figure 3.41: Tree at lower trail's edge about 60' north of wayside #1. Concrete is in poor condition in several areas along the lower trail. (Source: QE|A 2003, Roll5-13)

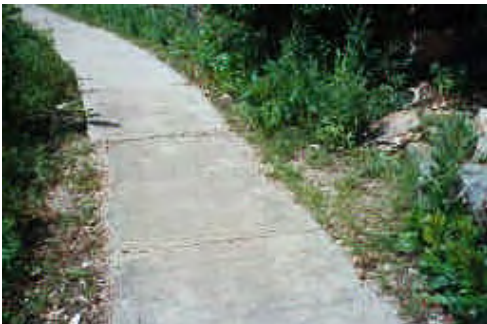
Figure 3.49: Lower trail concrete in poor condition near small cave opening located to the south of the historic cave entrance. (Source: QE|A 2003, Roll5-16)

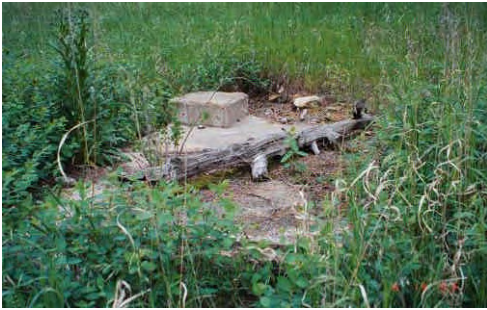
Figure 3.47: Concrete foundation, remnant of former structure in Hell Canyon. (Source: QE|A 2003, Roll 1-23)

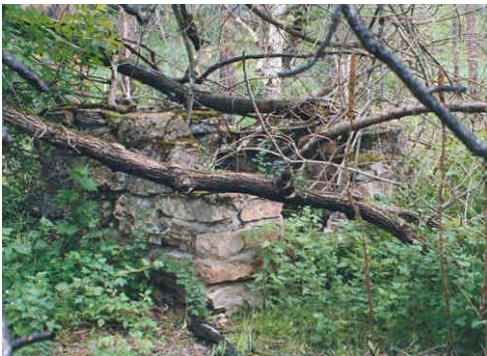
Figure 3.48: Remnants of fireplace in Hell Canyon. (Source: QE|A 2003, Roll 1-22)

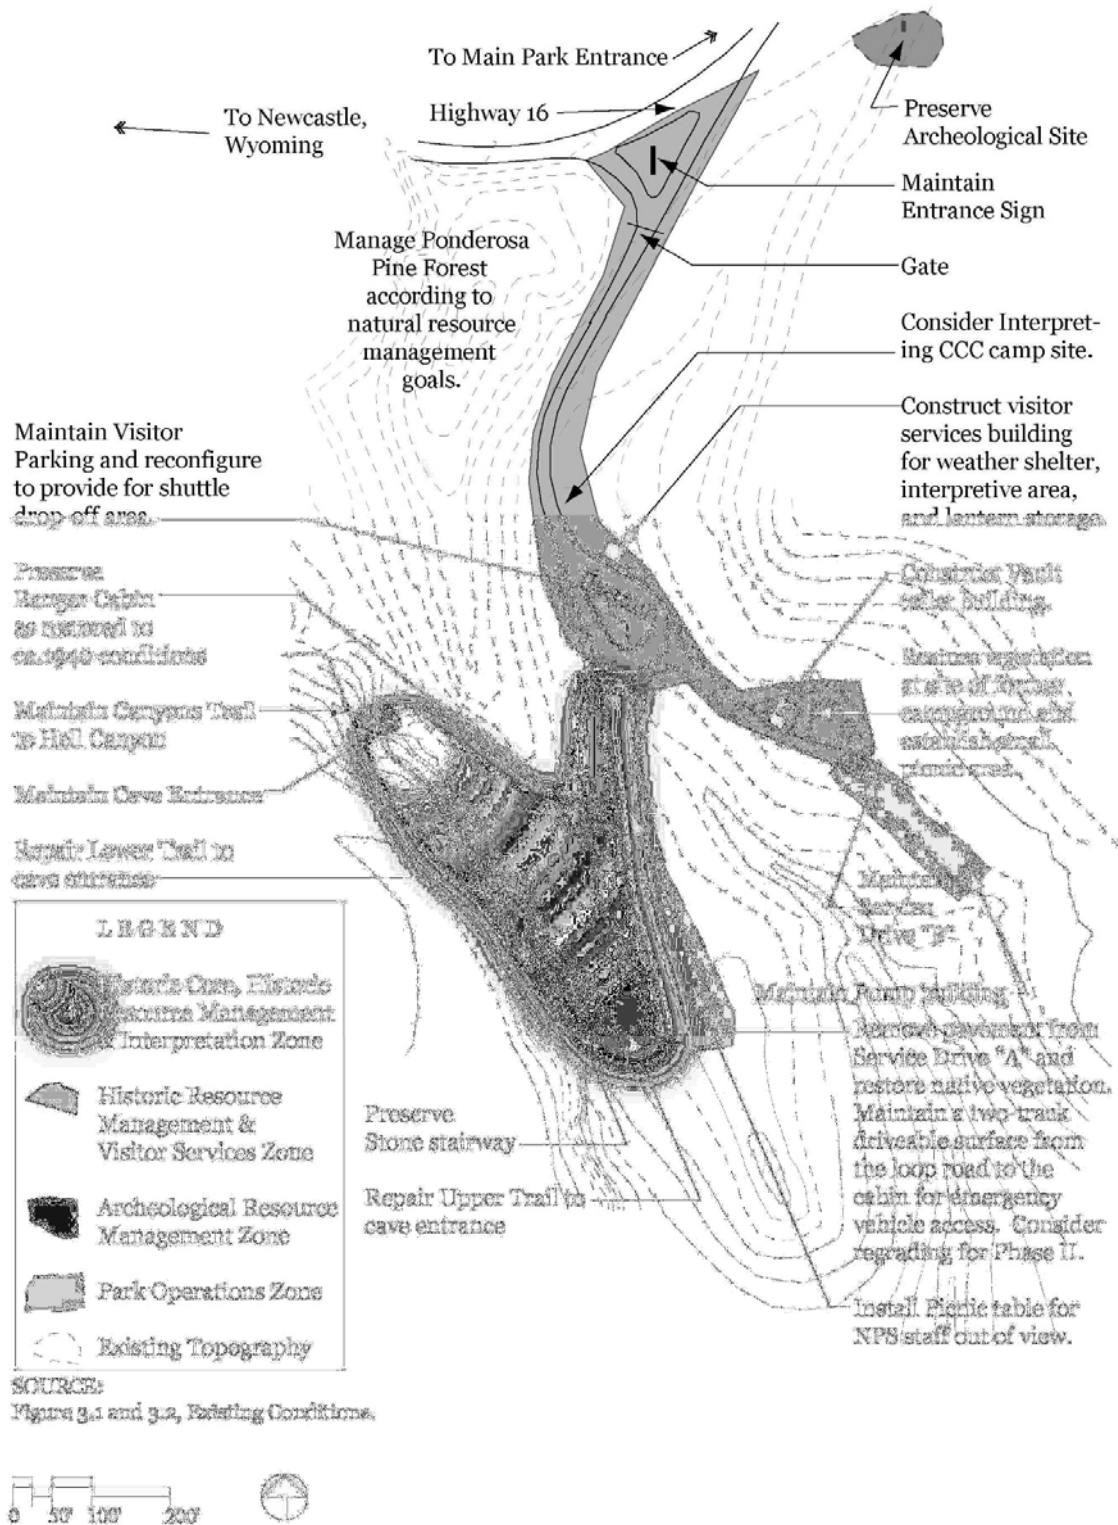
Figure 6.3: Treatment Alternative #3: Rehabilitation with Improved Visitor Services

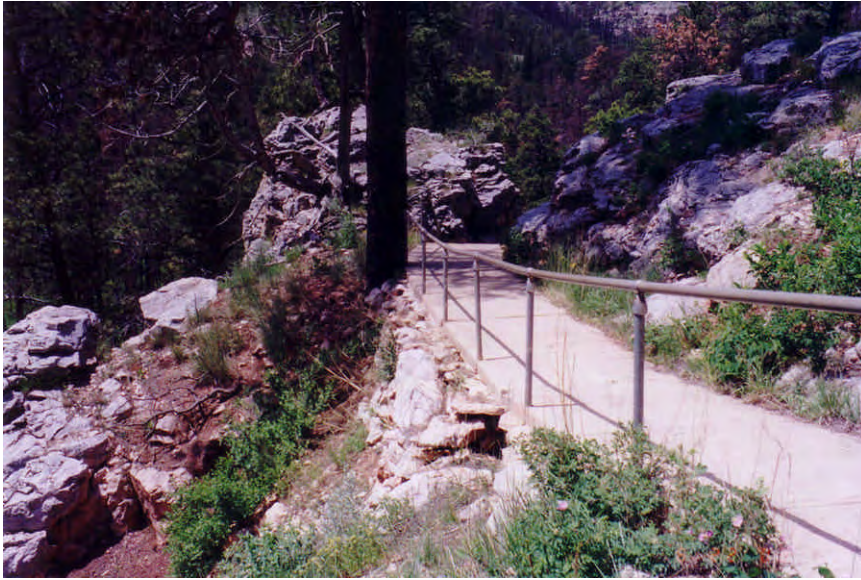
Figure 8.9: Existing conditions, Sidewalk and Railing above CCC-Constructed stone stairway (Source: QEA, June 2003)
